Corrosion

Exclusively

- The risks of ignoring maintenance – Moradi Bridge
- Field joint coatings
- Eliminating coating failures
- The worlds largest moveable structure
- Darlington Upgrade Project
- Feedback on AfriCORR

OFFICIAL MAGAZINE OF THE CORROSION INSTITUTE OF SOUTHERN AFRICA

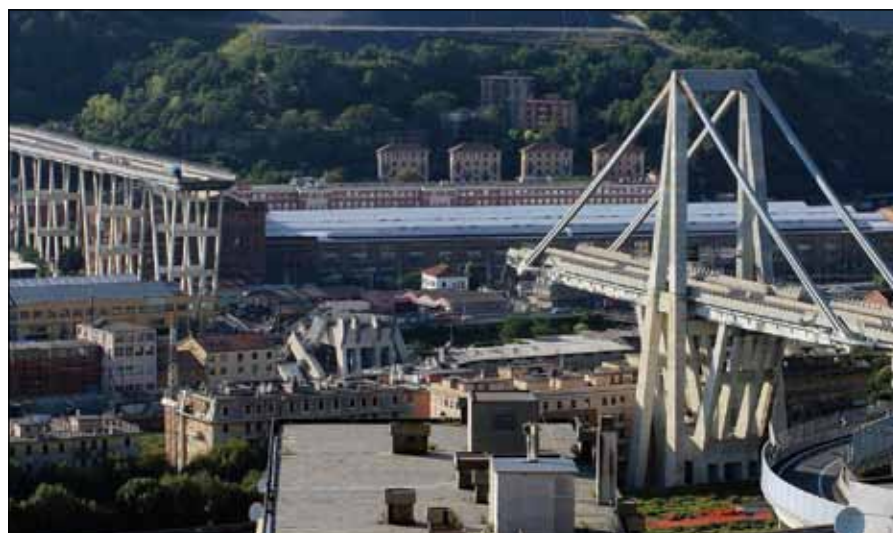
The bridge after the partial collapse in August 2018.

It has been reported that the southern stays gave way explosively due to corrosion and damage. With only four stays, if one of them had given way, the structure could have lost stability. An investigative preliminary report suggests the pillar itself may have collapsed instead first. This conclusion was criticized, as a video provided by the adjacent Ferrometal company showing the southern stays gave way first and which is in possession of the prosecutors had not been seen by the investigative committee. There is speculation that lightning may have struck the stays, or a landslide could have destabilized the base.

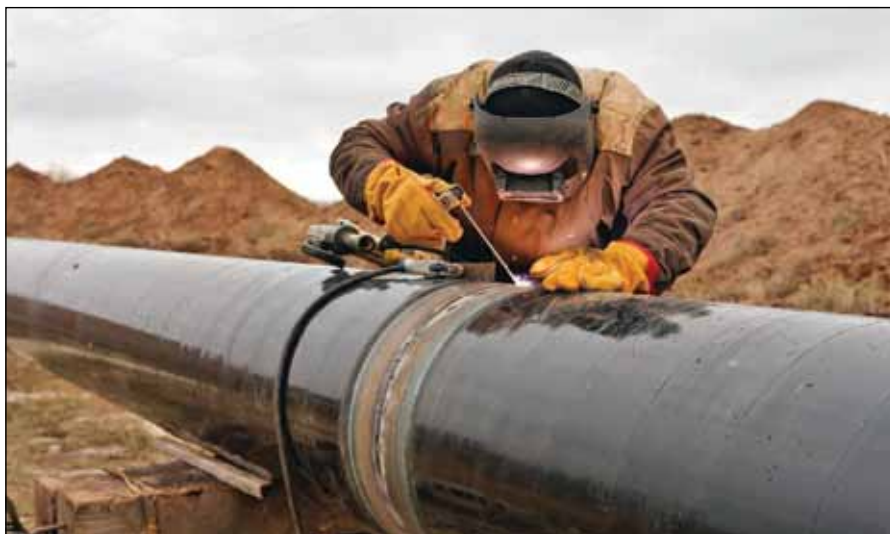
A field joint coating system must be integrated into a pipeline's construction conditions.

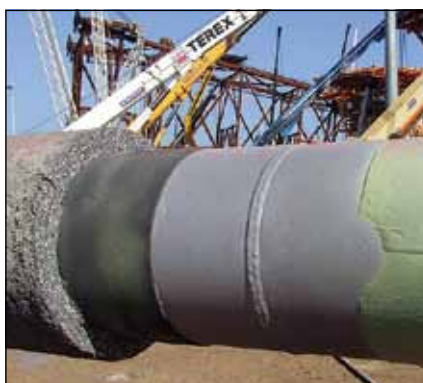
Field joint on riser.

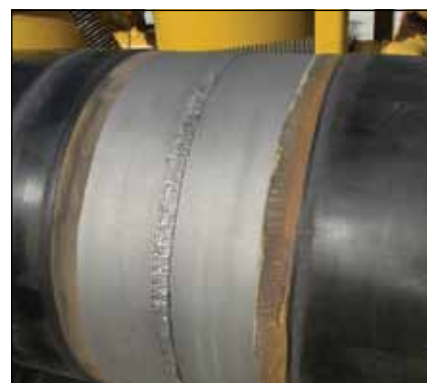
A close up of a welded and repaired field joint.

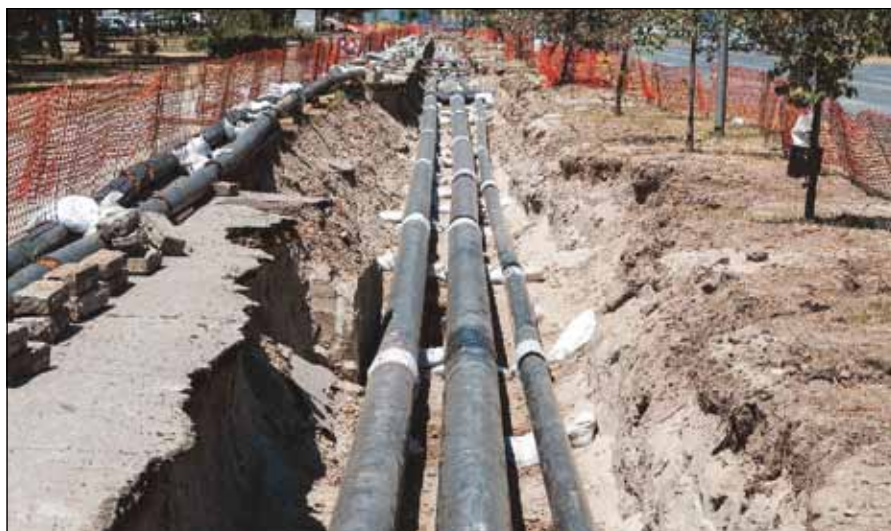
Protecting buried pipelines involves prevention of third-party drainage to coating and CP systems, as well as effective corrosion control.

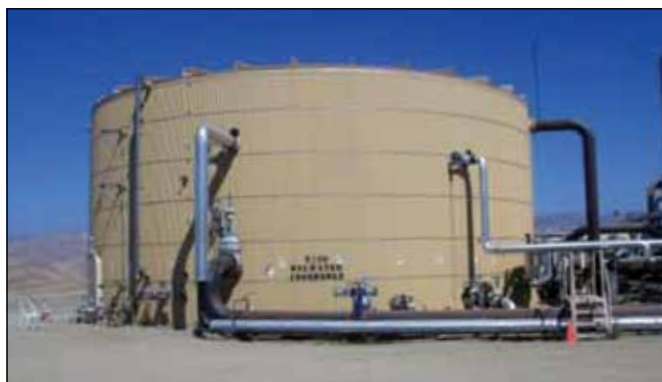
Water is typically accumulated in 5 000- to 10 000-bbl (795 000 - to 1.59 million-L) produced water tanks.

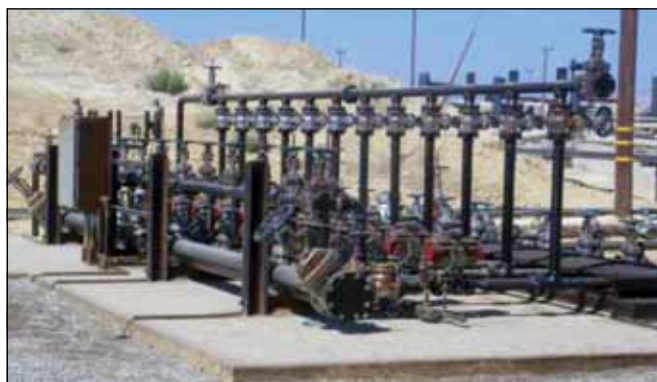
Figure 1: Steam injection platform.

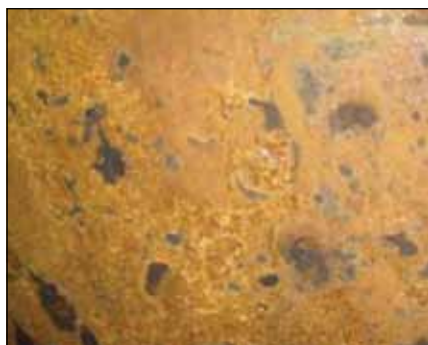
Figure 2: Corrosion on the inside of the produced water tank.

failed coatings indicated 12 to 16 mils (300 to 400µm) of dry film thickness; however, it was not the coating that was intolerant to the service but rather inadequate surface preparation that led to osmotic blistering and spot coating failures (Figure 2). Modification of surface preparation methods by incorporating the use of ultra-high water pressure blasting did not resolve the problem.

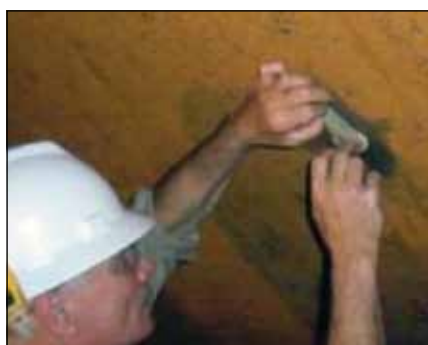
Figure 4: Surface testing.

No. 1/SSPC-SP 5² (white metal) (Figure 3) and followed by surface testing to ensure the salt limits have been met. The test kit is specified for testing surface chloride, nitrate, and sulfate ions. The limits are non-detectable levels of chloride, 5 µg/cm² for nitrate, and 5 µg/cm² for sulfate. The anchor profile required is 2 to 4 mils (51 to 102µm) (Figure 4).

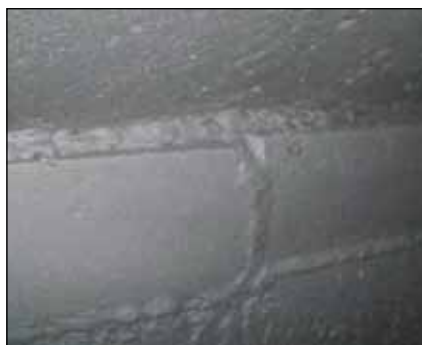
Figure 3: White metal blast, as defined in NACE No. 1/SSPC-SP 5.

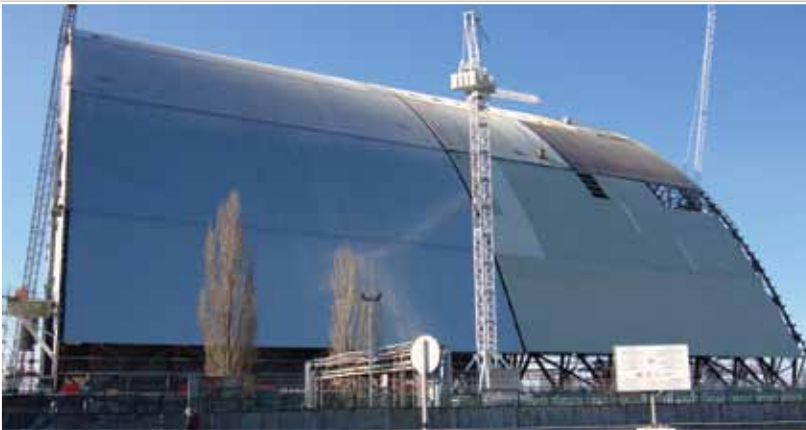
Cladding

The external cladding covers an area of 85 000m². It is a multilayer system of physical barriers restraining the spread of moisture, air and heat. The external cladding provides for resistance against atmospheric effects (rain, snow, extreme temperatures) for the whole 100-year operational life of the NSC, and is designed to withstand a tornado of class 3. It supports tightness of the annular space with possible atmospheric leakages of 65 litres per m² per hour at the beginning of the NSC operation and 275 litres per m² per hour at the end of the NSC 100-year service life.

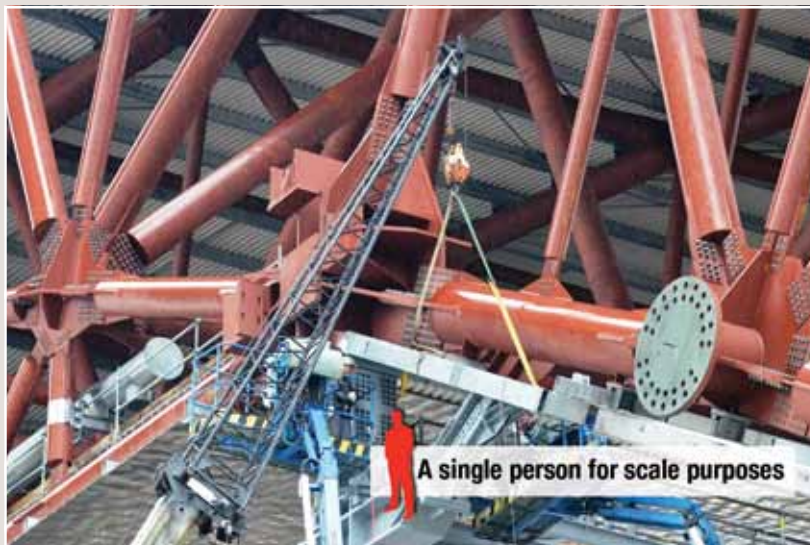
Arch main structure

The height of the steel arch is 108m, the length is 162m and the arch span is 257m. The main load-bearing structure of the NSC consists of 16 steel arch trusses. Each arch truss consists of two chords and a triangular truss girder. The distance between arch truss chords is 12m. The arch trusses are gathered in one supporting area on foundations.

The trusses are coupled with a system of beams and connections. Upper cladding purlins are supported by the upper chord of the arch, while internal cladding structures are fixed on the lower chord. The main steel structure weighs around 30 000 tons.

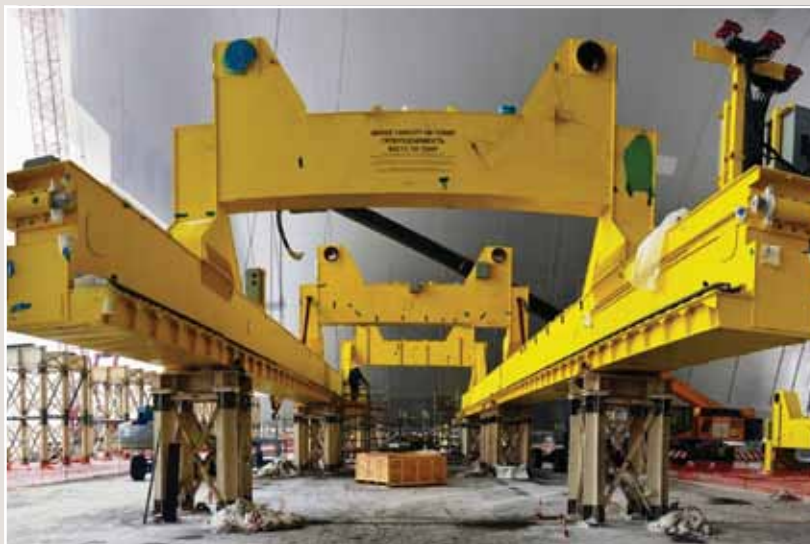
Main crane system

The main crane system is the central piece of equipment inside the arch to support long-term deconstruction of the shelter. It is installed inside the NSC just below the ceiling at 80m above ground level and will be controlled by a remotely controlled system and a video surveillance system that allow the operators to remain outside the NSC. It has been specifically designed for dismantling the main structures of the destroyed reactor and original sarcophagus and for handling heavily shielded waste disposal. It is composed of two bridges that are designed to carry three interchangeable carriages. The bridges are 96m in length and travel on six runway rails. There are two carriages for lifting, the secure and classic carriage with 50-tonne capacity, and one carriage that is a tool-delivery platform. It was designed and manufactured by PaR Systems Inc.

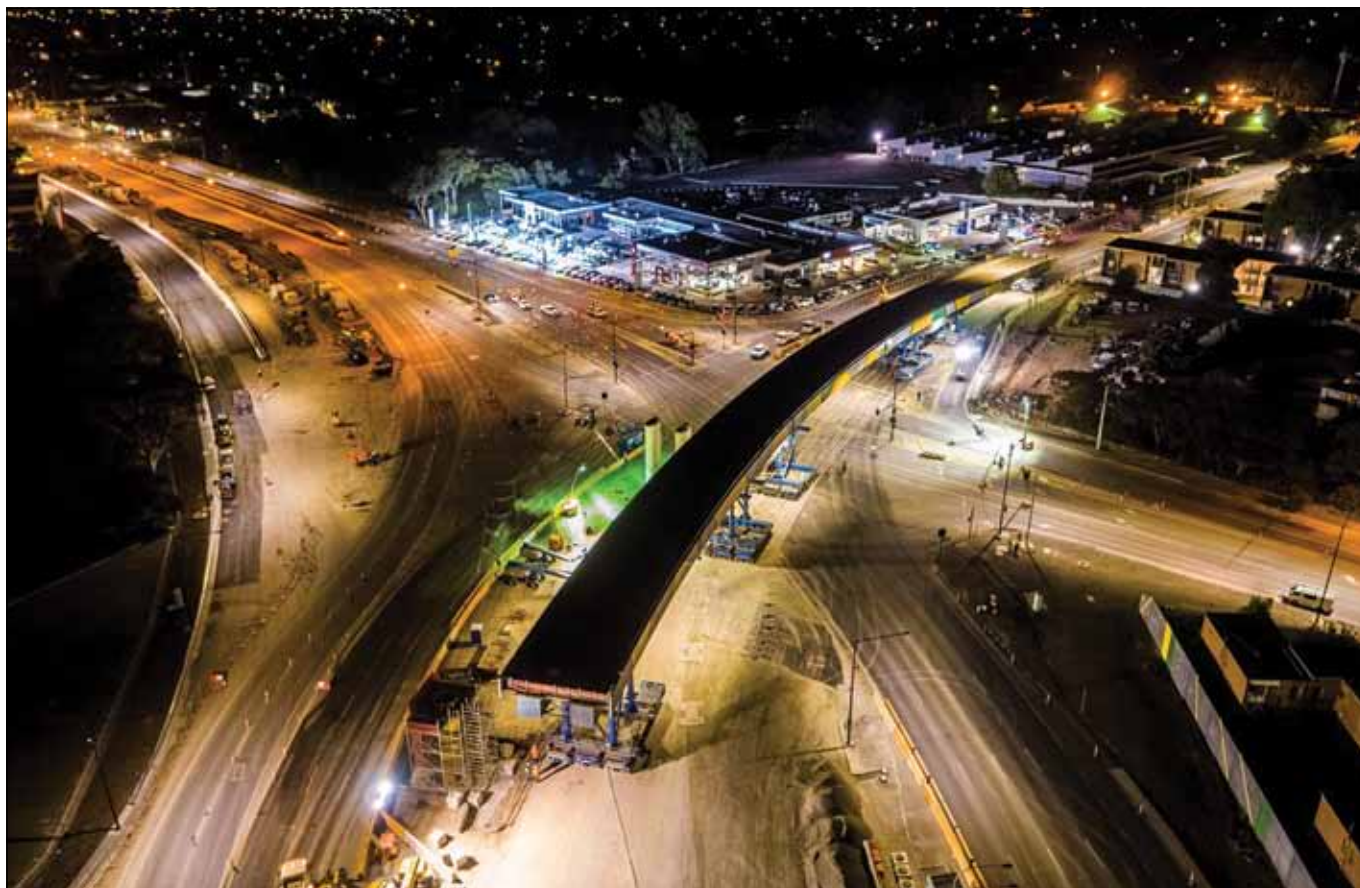
Installation of Ayliffes Road Bridge.

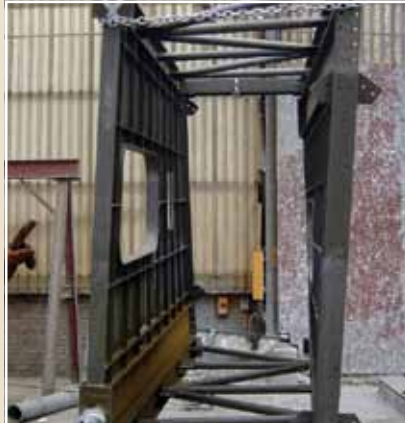
When delivered components are already distorted due to weld imbalances, galvanizers are to notify the client and suggest alternative corrosion control.

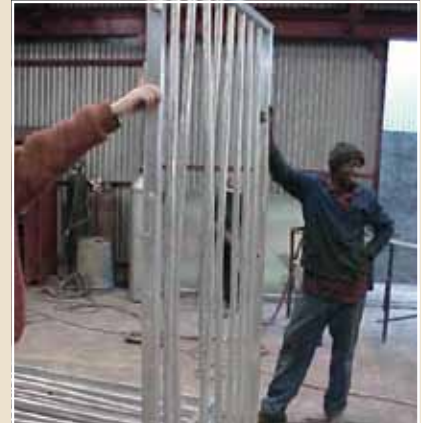
Varying thickness of steel making up a frame can cause differential expansion when dipped into molten zinc.

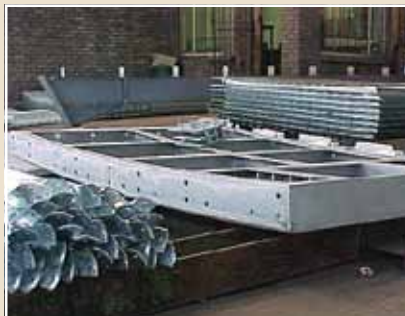
When hot dip galvanizing unsymmetrical components such as this, opposing residual forces can result in distortion.

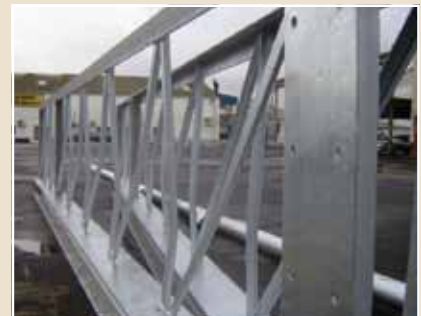
Varying thickness of steel making up a girder can cause differential expansion when dipped into molten zinc. The component may distort after hot dip galvanizing.

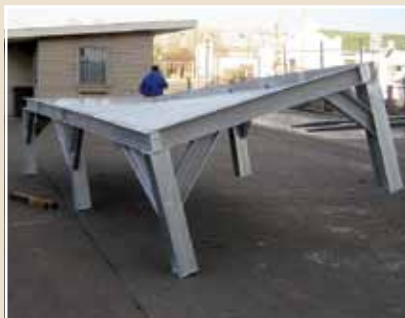
When hot dip galvanizing unsymmetrical components such as this, opposing residual forces can result in distortion.

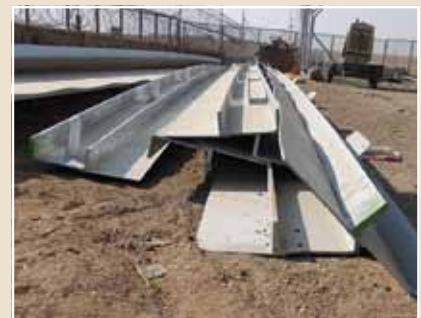
Long thick components welded to long thin plates that are unsymmetrical, can cause distortion of the thinner plate due to different heating cycles in the molten zinc.
